BMW E90 Misfire and Engine Management Light Illuminated

By Damien Coleman

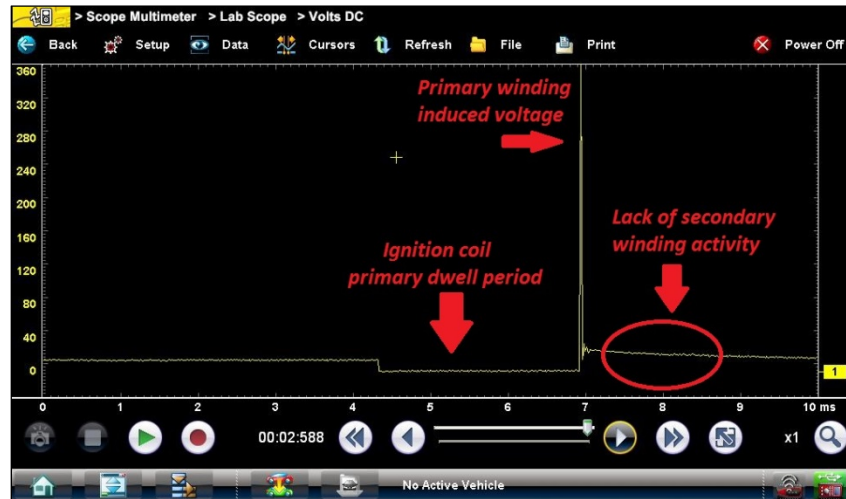
The oscilloscope was connected to the ECM ground control circuit pin on the ignition coil block connector to monitor ignition coil primary voltage. As the waveform displayed from the primary winding has a direct relationship to the activity taking place in the secondary circuit, any abnormalities can be observed (note: only primary voltage display to simplify image).

The above waveform indicated a problem in the secondary circuit which is integrated into the ignition coil assembly. The ignition coil was replaced for cylinder 1 and the following oscilloscope pattern was captured:

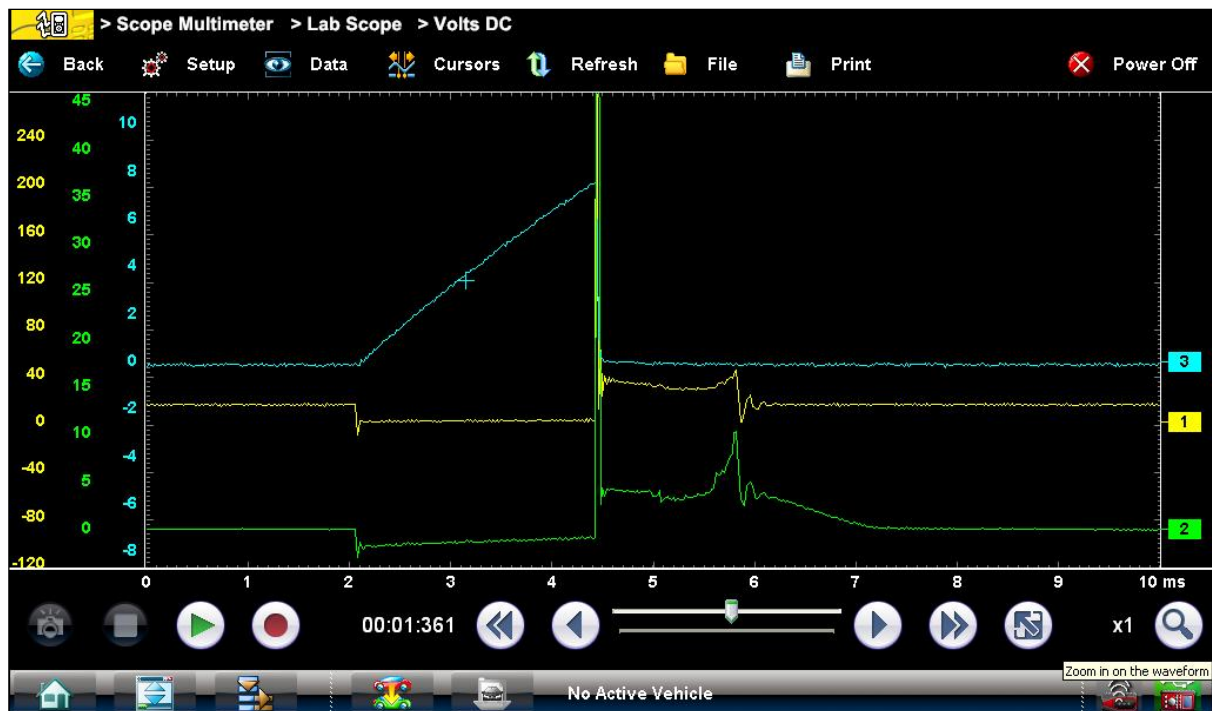
- Yellow trace:** Ignition coil primary voltage.
- Green trace:** Ignition coil secondary voltage.
- Blue trace:** Ignition coil primary control current.

The above image validates the repair for cylinder 1 misfire. The vehicle now operated as expected without any starting issues or misfires detected.

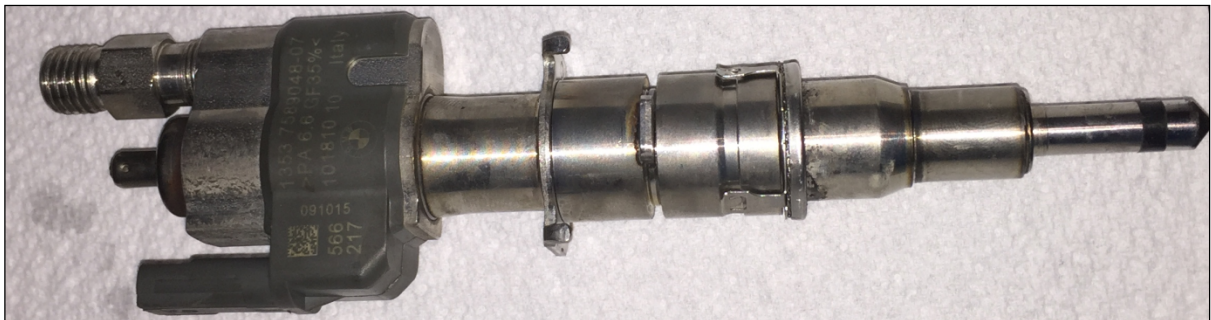
This engine uses high pressure piezo electric fuel injectors which operate at ≈ 150 Bar. The fuel is injected directly into the combustion chamber. If the injector fails in the open position unmetered fuel will be delivered directly into the cylinder.

The injector was removed from the cylinder head and fuel drips were evident at the tip of the injector. The fuel injector was again connected to the fuel rail via the high pressure pipe and the tip of the injector was inserted into a graduated container. When the low pressure fuel pump was activated unmetered fuel exited the injector which verified the initial diagnosis.

- Injector removed from cylinder head

The injector was replaced and coded using the scan tool. The injector must be coded to allow for individual characteristics for each injector created during the manufacturing process.
