BMW E90 Misfire and Engine Management Light Illuminated

By Damien Coleman

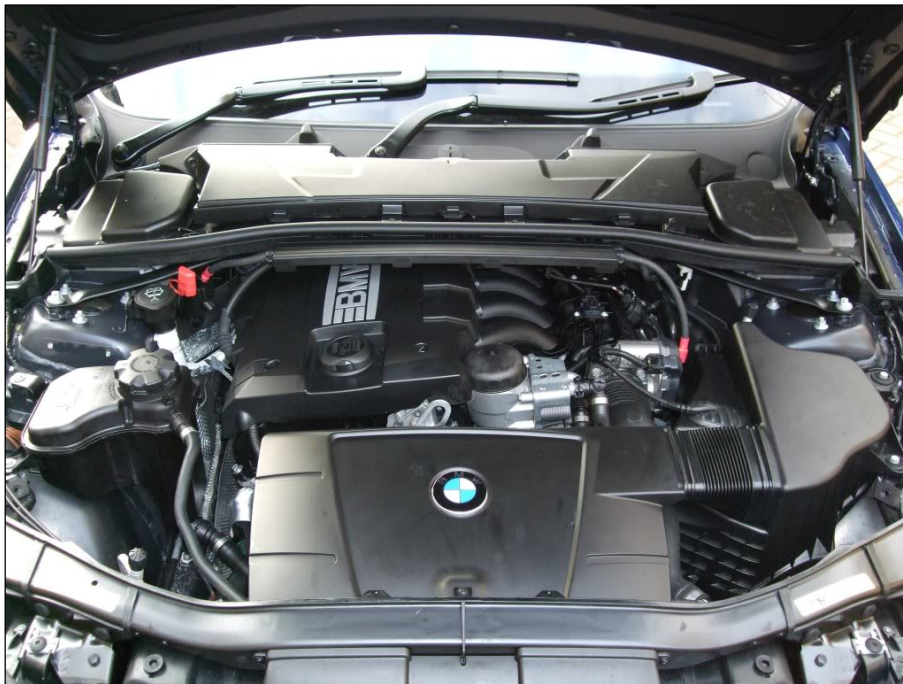
A 2008 BMW E90 with a 2.0L spark ignition engine (engine code: N43B20A) was reported to have been suffering from occasional rough running when starting and the engine management light was illuminating. When the vehicle was being tested initially there was no issue when starting it but a slight misfire was found under harsh acceleration.

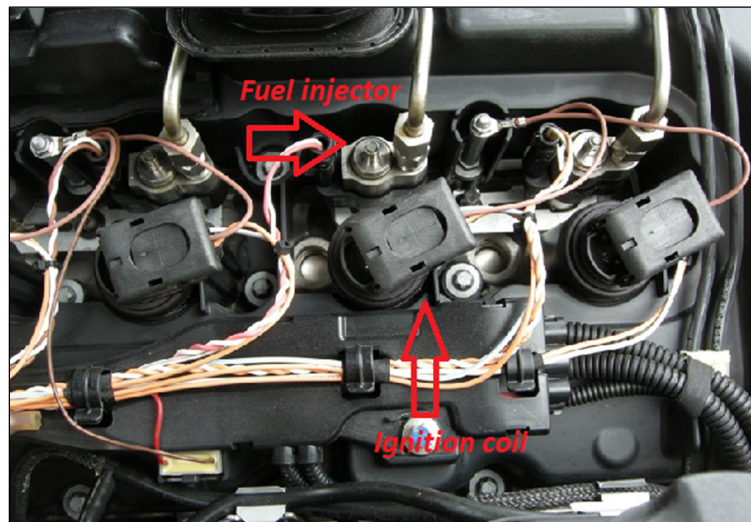
- Direct ignition coils and high pressure direct injection injectors

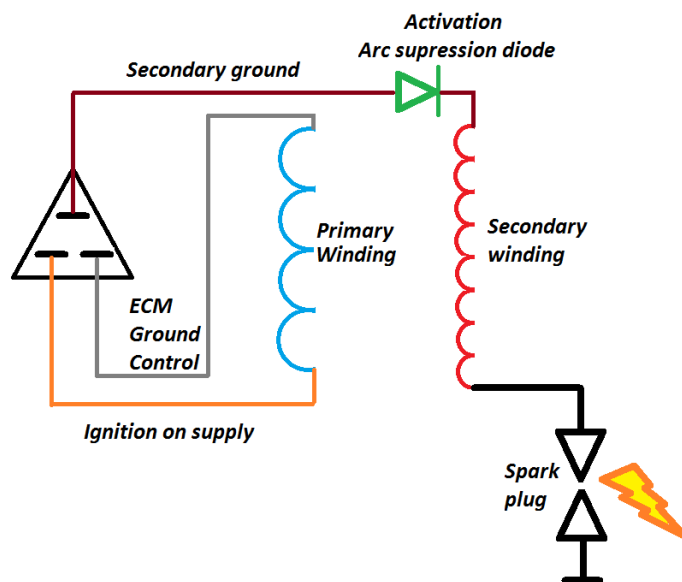
The purpose of the AAS diode is to eliminate "switch on" sparks in the secondary winding when current begins to flow through the primary winding.

These diodes are only fitted to direct ignition coils and are not required for wasted spark coils.
